**Prepared For:** Sample Report.  
(Name of Client)

**Concerning:** 907 Somewhere Drive. Dallas TX 76000.  
(Address or Other Identification of Inspected Property)

**By:** James A. Dickey. TREC # 5718. 7/31/08.  
(Name and License Number of Inspector) (Date)

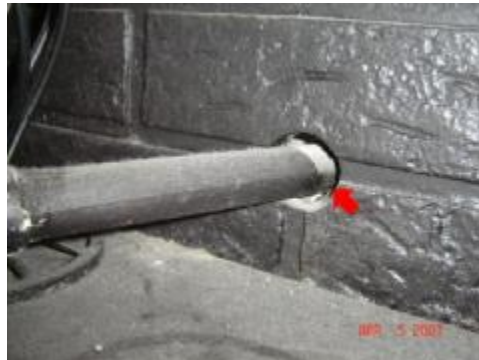
FIRE PLACE LOCATION- First Floor, Family Room. Fireplace is gas start, damper tested and wood framed, metal-lined chimney appears to be operating satisfactory. **Gas line for log lighter should be sealed where it enters the firebox. Ensure a high temperature sealant is used.**

Seal gas line in firebox.

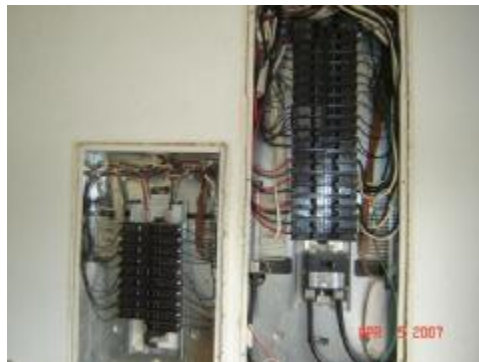
Main distribution panel is located in the garage, service is underground, 200 amps, copper, and uses breakers. Grounding clamp is visible and secure. A/C disconnects are located on the north side of the house and appear to be secure.

SUB-PANEL COMMENTS: Auxiliary distribution panel is located in the garage, 60 amps, copper, and uses breakers.

Main and auxiliary distribution panels.

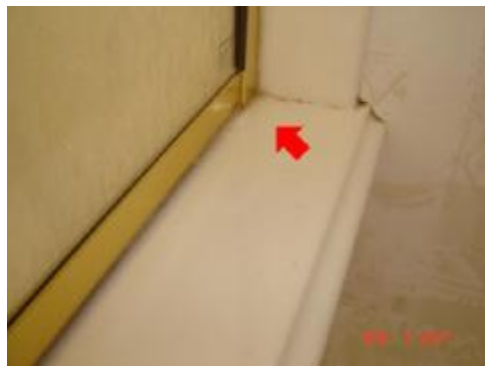
**Master bathroom shower leaks at enclosure. Water was observed on the outside of the enclosure when water was run. Recommend seal enclosure to help prevent moisture intrusion into home.**

Shower enclosure leaks.

Master bathroom shower leaks at enclosure. Water was observed on the outside of the enclosure when water was run. Recommend seal enclosure to help prevent moisture intrusion into home.

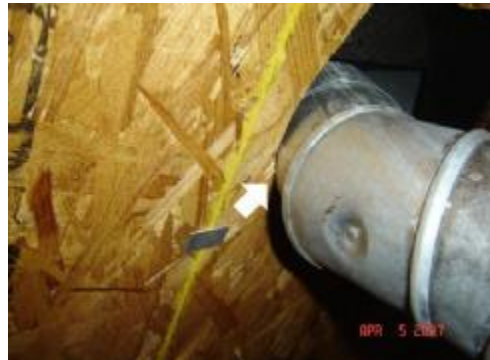
**Water heater flue vent is in contact with combustibile material in the attic. Recommend trim decking away from flue vent as required.**

Flue vent is in contact with decking.

Water heater flue vent is in contact with combustible material in the attic. Recommend trim decking away from flue vent as required.

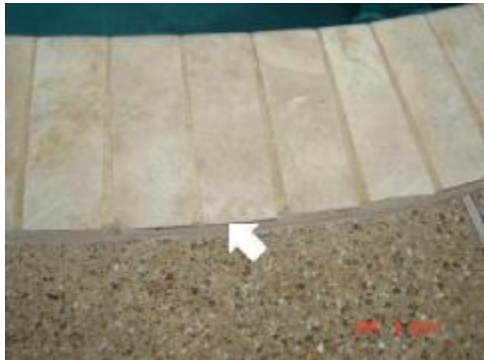
**TILES & DECK: Minor cracks were observed at deck-o-seal. Recommend repair by a pool professional.**

Minor cracks in Deck-O-Seal.

Minor cracks were observed at deck-o-seal. Recommend repair by a pool professional.

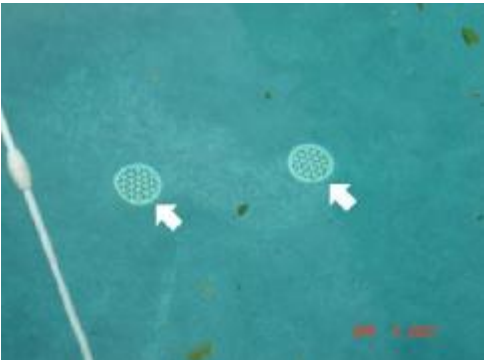
**SKIMMERS & DRAINS: Anti-Vortex drain covers are not installed. Recommend replace old drain covers with anti-vortex drain covers as required.**

No anti-vortex drain covers.

Anti-Vortex drain covers are not installed. Recommend replace old drain covers with anti-vortex drain covers as required.
